METALS HANDBOOK

VOL. 9
FRACTOGRAPHY AND ATLAS OF FRACTOGRAPHY

8th EDITION

Fractography and Atlas of Fractographs

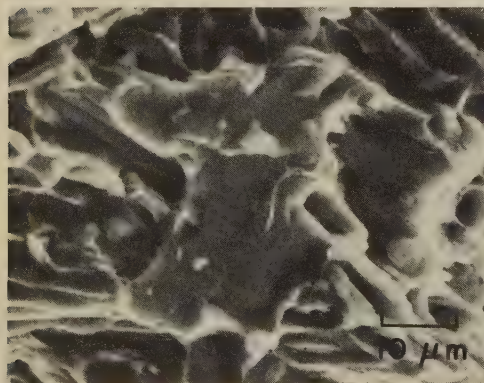
SEM fractograph 300×

3990 View at another location in the fracture surface in 3985. The formation of the cellular structure shown here and in 3988 is attributed to the microstructure that resulted from the freezing patterns and heat treatment of the casting.

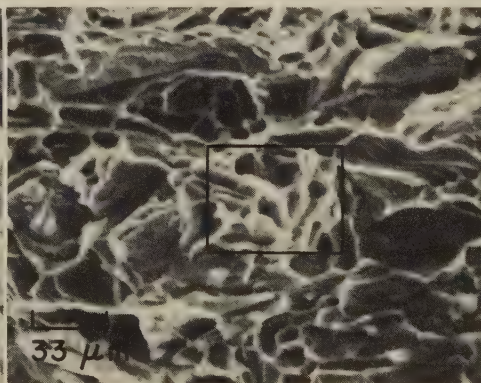
SEM fractograph 1000×

3991 Another view of the fracture surface shown in 3985. As in 3989 and 3990, there is no evidence of true dimples, but cellular structure only. There appear to be many small inclusions on the surface; most are not bonded to the matrix.

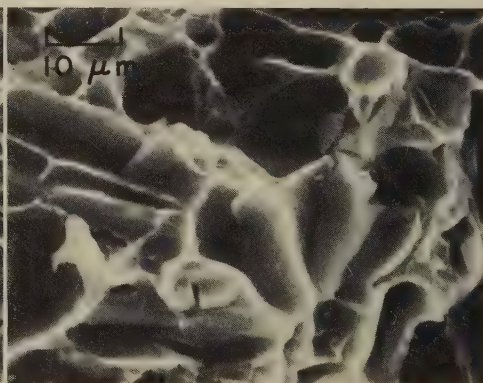
SEM fractograph 300×

3992 An overload fracture in a miniature tensile-test specimen cut from the fitting in 3985, displaying the same type of cellular surface structure produced by the service fracture. See 3993, a higher-magnification view of the area in the rectangle.

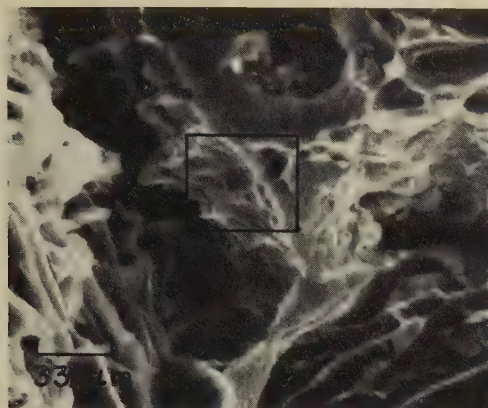
3993 A higher-magnification view of the area outlined by the rectangle in fractograph 3992. Although the features here strongly resemble those shown in 3989, close scrutiny reveals the presence of tiny dimples in the edges of some cells.

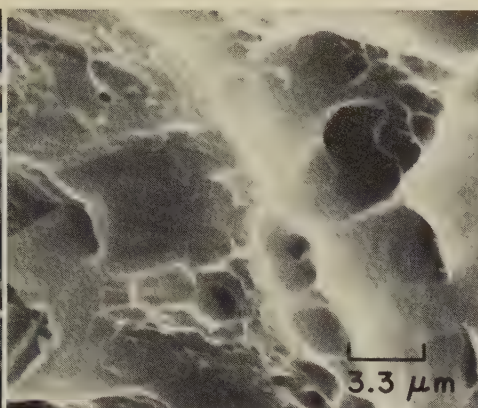
SEM fractograph 300×
3994 View of the fracture surface shown in 3992, but at another location. In this area, there are small, clearly visible dimples clustered in the central, outlined region, which is shown at higher magnification in fractograph 3995 (right).

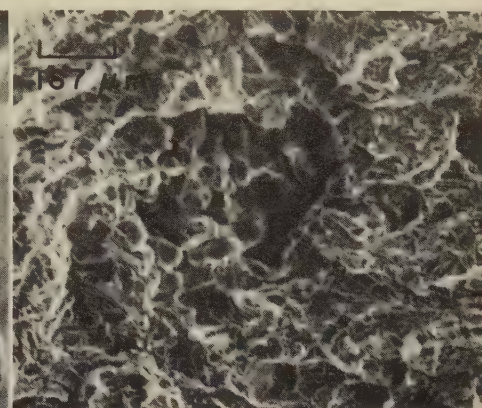
SEM fractograph 3000×
3995 A higher-magnification view of the area in the rectangle in 3994 (at left), showing small dimples of several sizes and suggesting that the service fracture shown in 3985 (with no dimples) was not the result of simple overload.

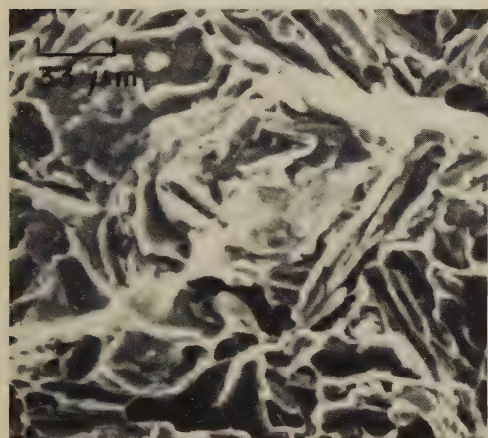
SEM fractograph 60×
3996 Surface of a fracture in a miniature impact-test specimen cut from the broken aluminum alloy 356-T6 bell-crank fitting shown in 3985. The appearance here is very similar to that of the service fracture in 3986, at the same magnification.

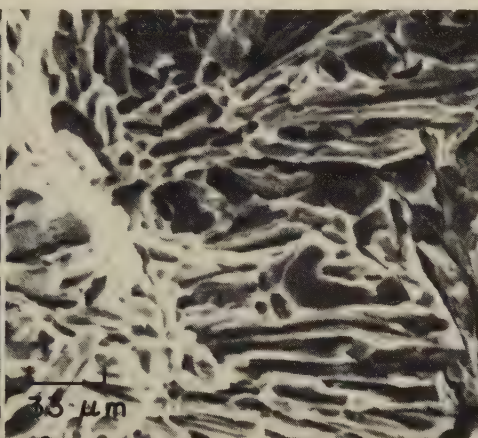
SEM fractograph 300×
3997 View of the fractured test specimen in 3996, but at another location. The appearance here is quite similar to that of the service fracture in 3990.

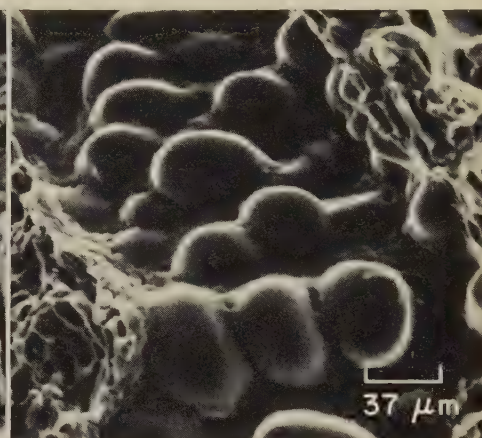
SEM fractograph 300×
3998 Another view of the fracture surface shown in 3996 and 3997. Compare with the view of the service fracture in 3988 and note the marked resemblance.

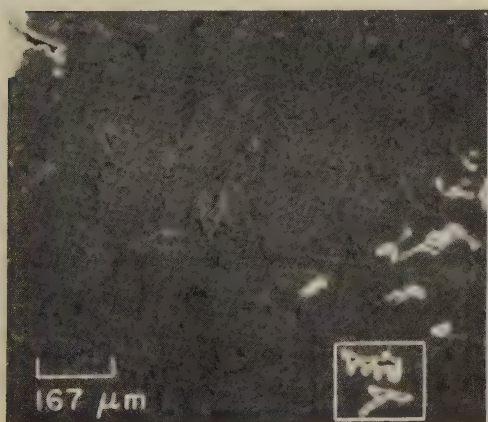
SEM fractograph 270×
3999 View of fracture surface in 3996-3998, displaying a shrinkage cavity. Cavity is somewhat like those in 3987, but with a much coarser dendrite cell structure.

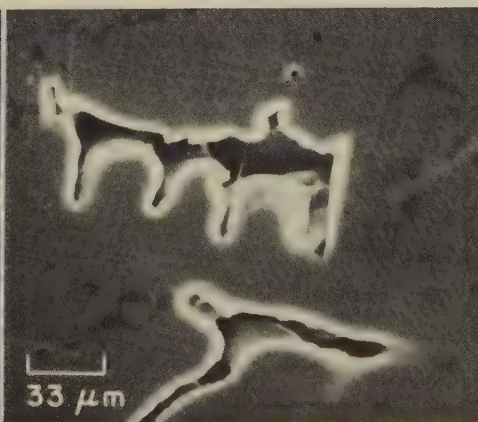
SEM micrograph (as polished; not etched) 60×
4000 A polished but unetched section of the broken fitting in 3985, showing the expected dendritic network of silicon particles (dark features; see 4002) and light shrinkage cavities (see 4001 for a higher-magnification view of the outlined area).

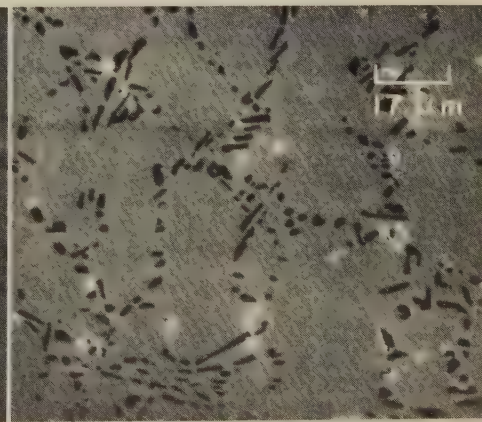
SEM micrograph (as polished; not etched) 300×
4001 A higher-magnification view of the shrinkage cavities shown in the outlined area in micrograph 4000 (left). Note that the shapes of these shrinkage cavities are very conducive to crack propagation with little plastic deformation.

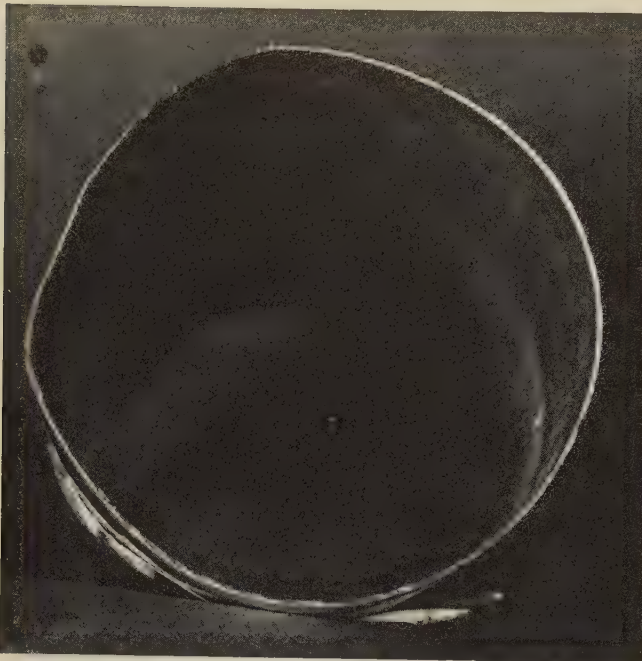
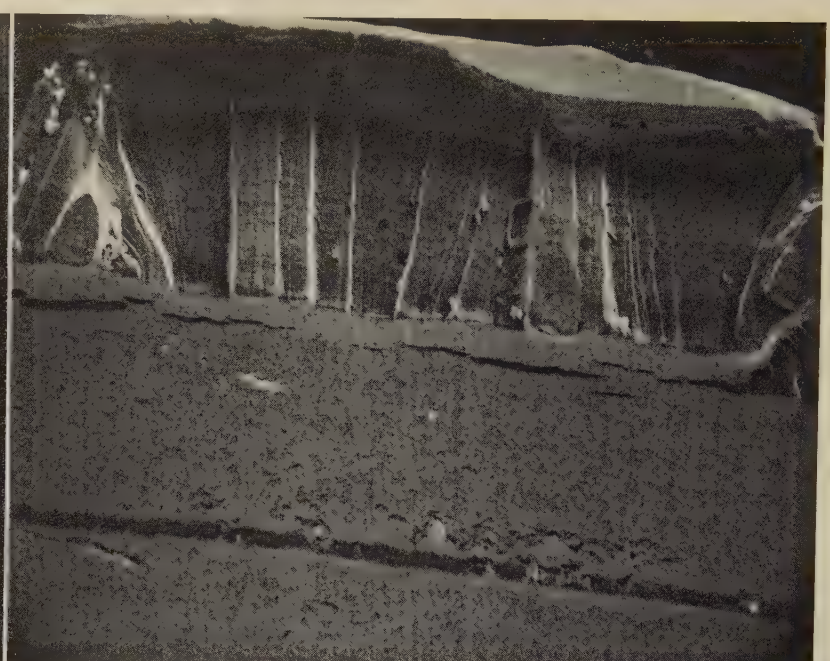
4003, 4004 Photograph and SEM fractograph showing the fracture surface of a small portable cylinder used for storage of helium gas under pressure that exploded while at rest in storage. The cylinder was approximately 2 3/4 in. in diameter by 10 in. long and had been formed from a 0.03-in.-thick sheet of aluminum alloy 1100. Normal pressure in the cylinder, when full of helium, was 2 MPa (300 psi); maximum pressure, 4 MPa (600 psi). The cylinder broke when the bottom separated from the sidewall with explosive force, leaving a very even fracture surface; separation was probably at the very bottom of the sidewall. Photograph 4003 (left) shows the entire levels, separated by offsets, containing crack arrests. Rupture began at the inside of the cylinder wall and terminated in a pronounced ductile shear lip (at top in 4004). Note the secondary stress-corrosion cracks in the inside surface of the wall (at bottom in 4004), which are parallel to the fracture surface. See also fractographs 4005 and 4006 (below).

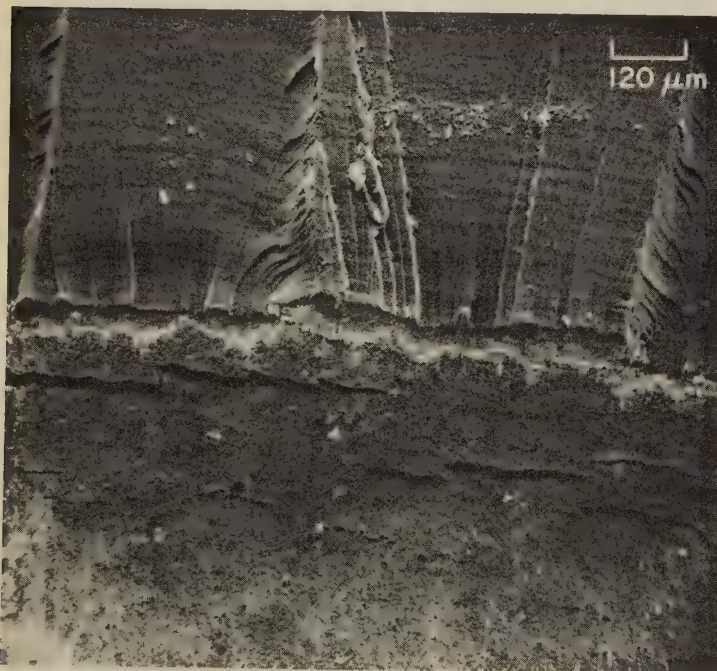
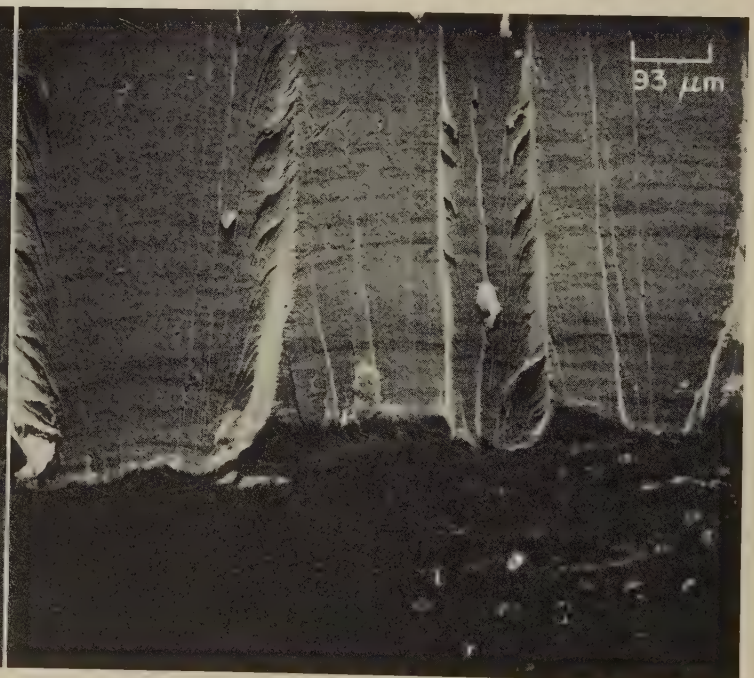
4005, 4006 SEM views of two portions of the fracture surface of the cylinder in 4003 (above, at left). These views, at higher magnification than 4004, also show the crack arrests, the offsets between adjoining stress-corrosion-crack surfaces, and the numerous secondary cracks in the inside surface of the cylinder wall (at bottom) that are parallel to the fracture. In 4006 (right), numerous corrosion pits are visible also. These pits are probably due to condensation of water vapor, at the bottom of the cylinder, that was carried by the helium gas. (Light-microscope examination revealed that cracks formed at bottoms of corrosion pits.) It is likely also that the forming operation created large stress concentrations at the junction between the sidewall and the bottom of the cylinder.

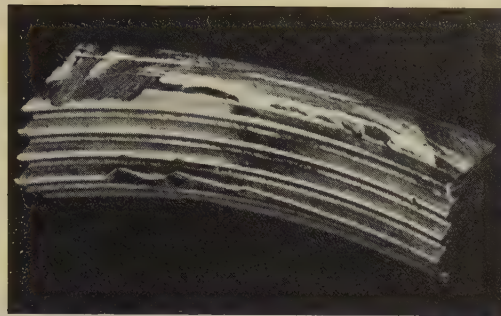
Photograph 2/3×
4007 Segment of a propeller hub, of aluminum alloy 2014-T6, that fractured in service by fatigue. Fracture surface, seen obliquely across the top of the segment here, is shown in a frontal view in 4008, at right. See also 4009 to 4014, below, and 4015 to 4020, on the next page.

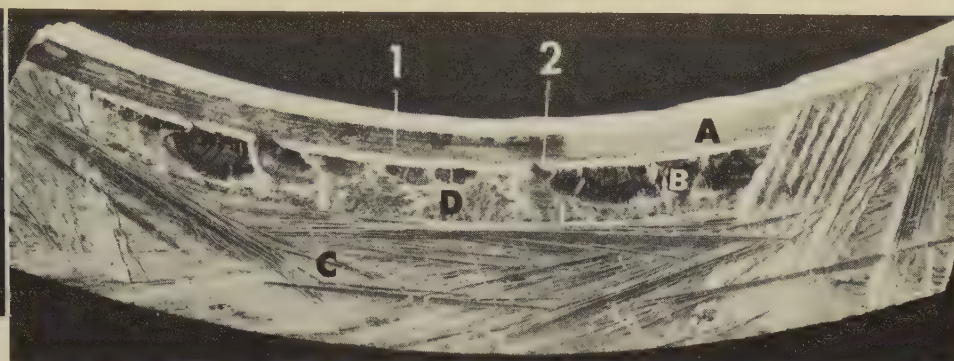
Light fractograph 5×
4008 Frontal view of the fracture surface shown obliquely in 4007 (left). The narrow ledge at "A" is the top thread visible in 4007. The dark area at "B" is the surface of one of the original (fatigue) cracks. Saw cuts ("C") were made partway through the hub segment, and the original cracks were then exposed by overload fracture, which produced the surface at "D". See 4010 and 4014 for enlarged views of areas 1 and 2.

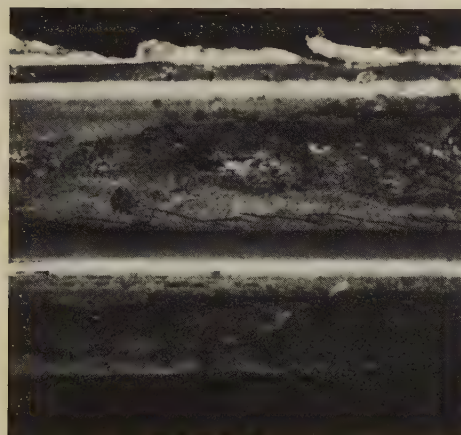
Photograph 6×
4009 View of the root of a thread in the propeller-hub segment shown in 4007, revealing that cracks had formed other than those that caused the fracture. Note the layers of corrosion products on thread surfaces. See also fractograph 4020, on the next page.

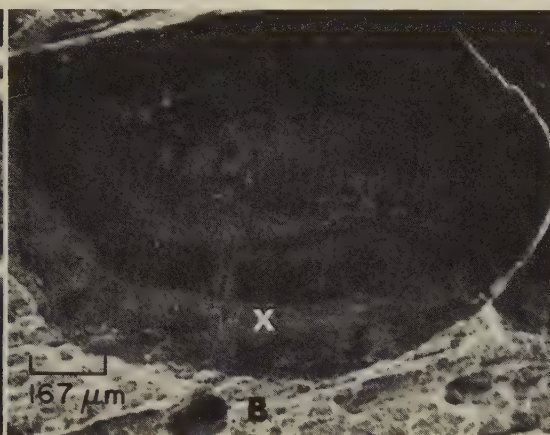
SEM fractograph 60×
4010 Higher-magnification view of the area in 4008 marked 1. The bright region at bottom ("B") is the surface of the overload fracture produced to expose the original cracks. The center region of the fatigue-crack surface (dark) is quite corroded; the outer region at "X" (shown at higher magnification in 4011) is relatively clean.

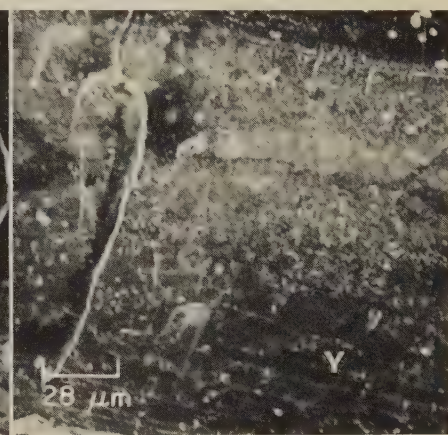
SEM fractograph 360×
4011 Higher-magnification view of the fatigue-crack surface at "X" in 4010. Although some corrosion products are present, fatigue striations are still faintly visible in region "Y". Region "Y" is shown at higher magnification in fractograph 4012, below.

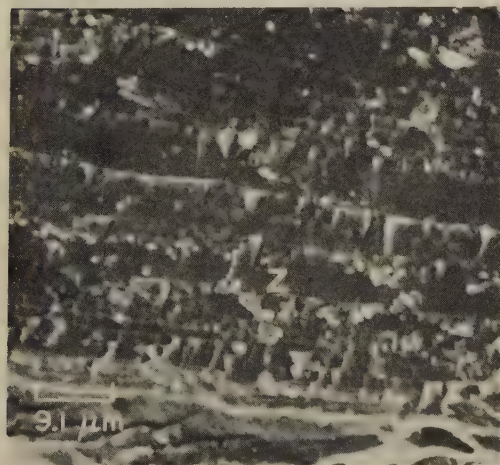
SEM fractograph 1100×
4012 Enlarged view of region "Y" in 4011. At this magnification the fatigue striations are clearly identified by the alignments of corrosion products. See 4013 for an enlarged view of area "Z".

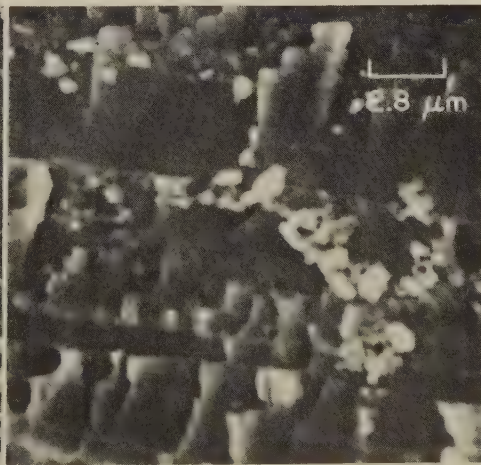
SEM fractograph 3600×
4013 A higher-magnification view of the area at "Z" in fractograph 4012, which shows that the corrosion products have formed shelves at the edges of fatigue striations.

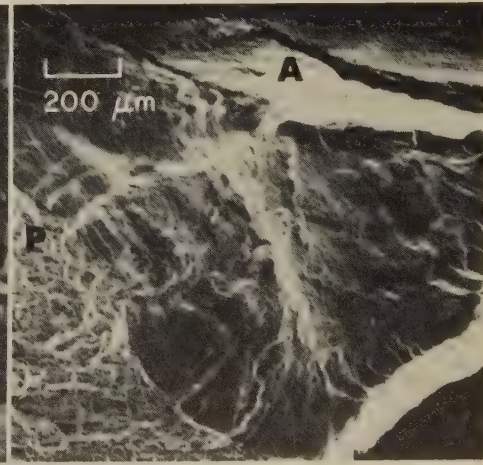
SEM fractograph 50×
4014 Higher-magnification view of area 2 in 4008, showing (at "A") the crack nucleus at the root of the thread. See 4015, on the next page, for a higher-magnification view of the area at "P".

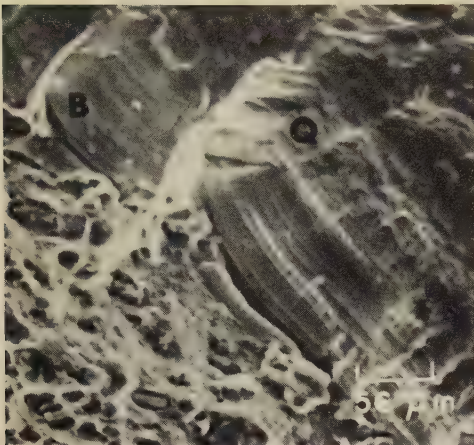
SEM fractograph 180×
4015 View of area "P" in fractograph 4014 (preceding page), at higher magnification. Area containing fatigue striations is at "B"; overload fracture that exposed the fatigue crack is at lower left. Area at "Q" is shown enlarged in 4016.

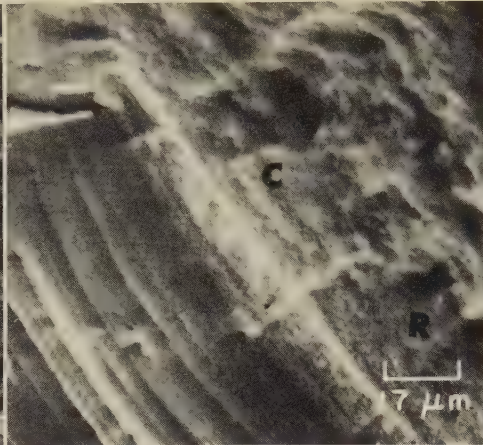
SEM fractograph 600×
4016 Area at "Q" in 4015, at higher magnification, which clearly shows the fatigue striations. Some of the striations (at "C") are partly obscured by the effects of corrosion. The area at "R" is shown at still higher magnification in 4017.

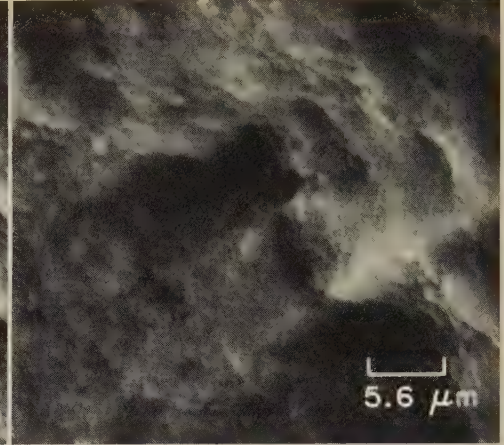
SEM fractograph 1800×
4017 A more distinct view, at higher magnification, of the corroded region at "R" in fractograph 4016 (at left). Some of the corrosion attack was general in nature, although numerous pits were formed by localized corrosion.

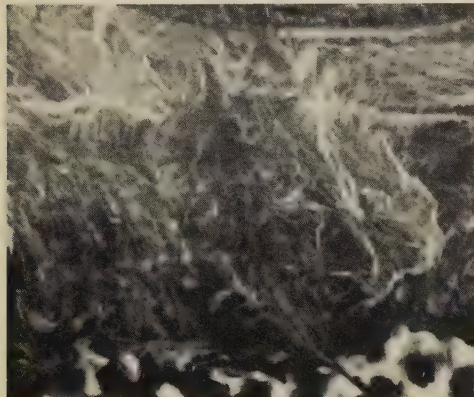
SEM fractograph 36×
4018 A crack in the propeller-hub segment in 4007 not seen in 4008. Fatigue beach marks are visible at uppermost right. The very bright areas at bottom are corrosion debris. See also 4019.

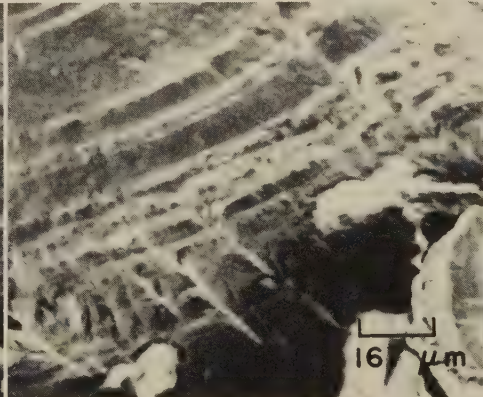
SEM fractograph 60×
4019 Area near site of origin of the fatigue crack in 4018. Note corrosion "spikes" issuing from beach marks. X-ray analysis identified bright debris as silicates of iron, cadmium and aluminum.

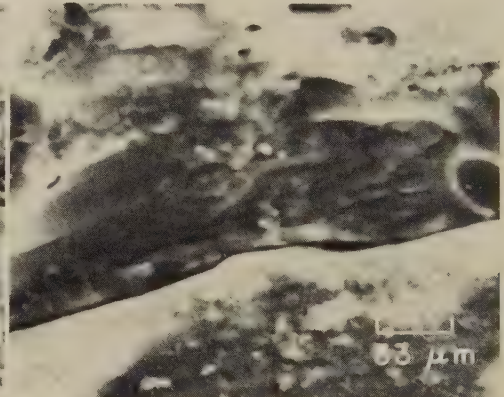
SEM fractograph 300×
4020 A view of the thread root in 4009 (preceding page) at considerably increased magnification, which more clearly shows the pitting, spalling, corrosion products, and one of the cracks in the root.

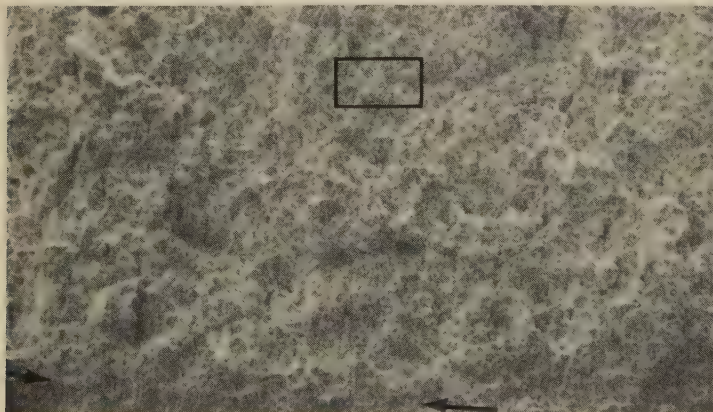
SEM fractograph 49×
4021 Fracture surface of a plane-strain fracture-toughness specimen of aluminum alloy 2024-T4 aged 48 hr at 23 C (73 F) before being tested. Tensile strength was 461 MPa (67 ksi). Termination of the fatigue precrack can be faintly seen across the bottom (arrows); above it is the later overload fracture. See 4022.

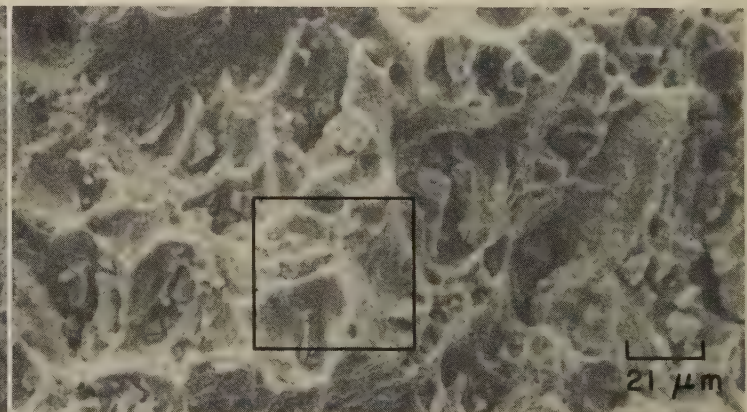
SEM fractograph 480×
4022 An enlarged view of the area outlined by the rectangle in 4021, in the overload portion of the fracture. Many areas of small dimples are visible surrounding larger cavities containing broken and cracked inclusions. For a higher-magnification view of the area in the rectangle here, see 4023 (facing page).

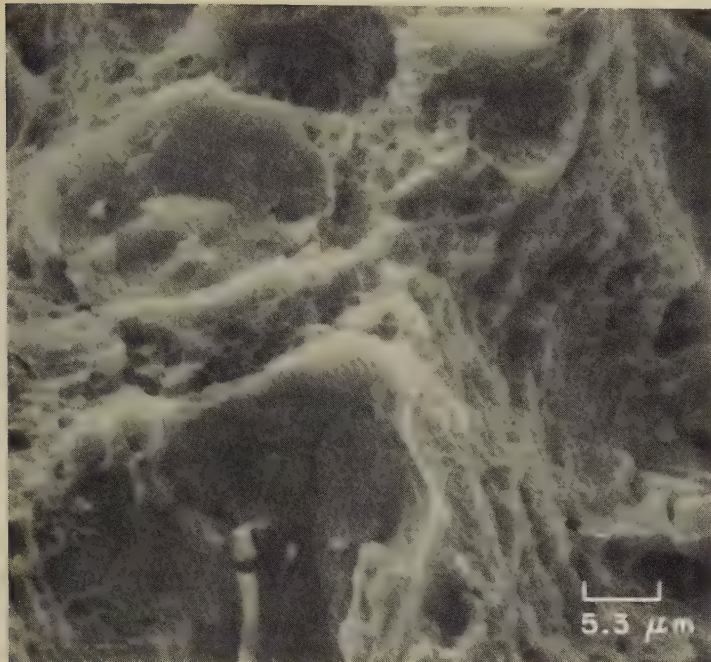
SEM fractograph

4023 This conclusion of the series begun in fractograph 4021 (opposite page) is a view at higher magnification of the area within the rectangle in fractograph 4022. Here, the small dimples, which are of quite uniform size, can be seen very clearly. At top is an area that appears to be a cleaved facet of an inclusion. At bottom is a large void that has evidently formed by separation from a slablike inclusion of which the edge is still visible at the center of the void.

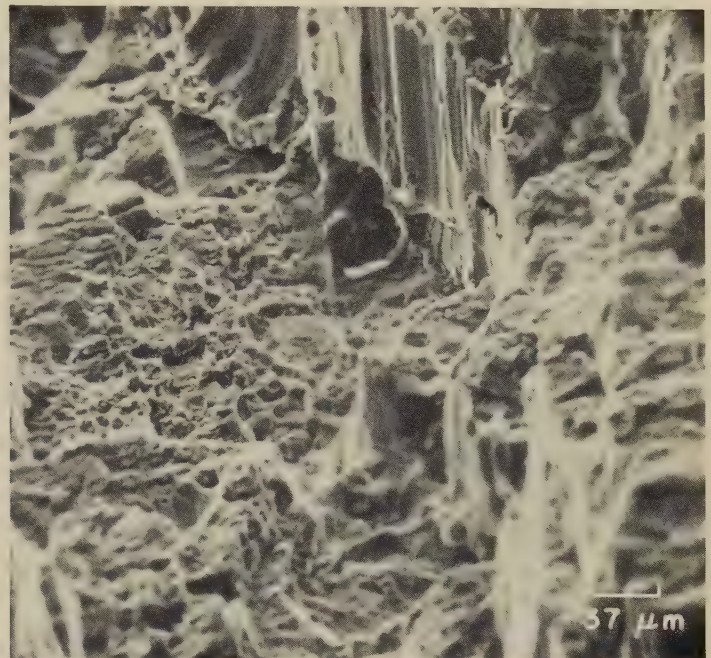
SEM fractograph

4024 Fracture surface of a fatigue-test specimen of aluminum alloy 2024-T3, showing a portion of the region of final, fast fracture. Stress-intensity range (ΔK) was 21 MPa·m^{1/2} (19 ksi·in.^{1/2}); the stress was applied in an argon atmosphere at room temperature at a frequency of 10 cycles per second. The area has voids that may be moderate-size dimples. The vertical face is apparently a very large tear ridge or cleavage step joining two areas of dimpled rupture. See also 4025, 4026.

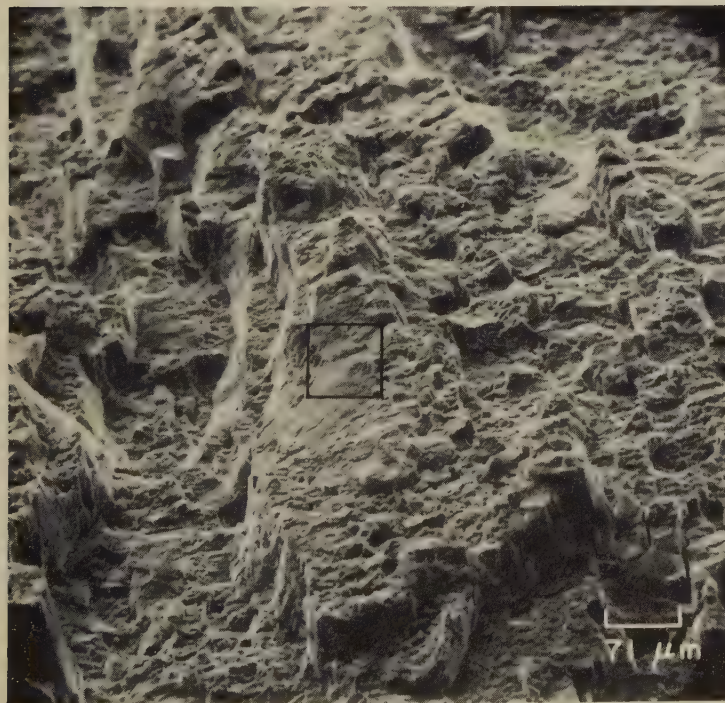
SEM fractograph

4025 A different area of the fracture surface shown in 4024. This also exhibits vertical faces that are tear ridges. The surface is covered with voids, but at this low magnification it is not possible to decide whether or not they are dimples. The smooth central area outlined by the rectangle is shown enlarged in 4026.

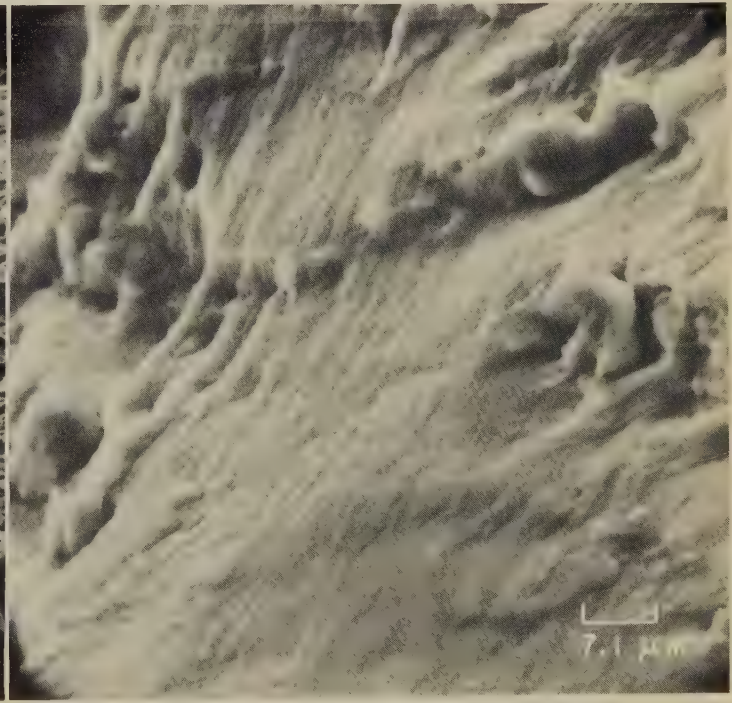
SEM fractograph

4026 A view of the rectangle-outlined area of the fracture surface in fractograph 4025, at higher magnification. With this enlargement, it is evident that the area is not truly smooth, but rather that it bears a uniform array of extremely fine fatigue striations. Near the right edge is a small area of minute dimples.

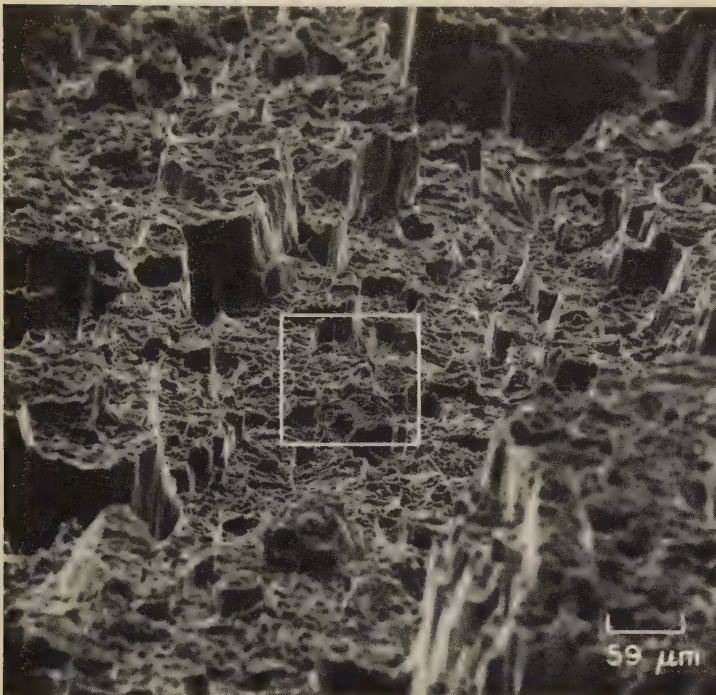
SEM fractograph

4027 Fracture surface of a fatigue-test specimen of aluminum alloy 2024-T3 tested at 23 C (73 F) in argon. The fatigue crack, similar in appearance to the one in 4025 (preceding page), was produced by a stress-intensity range (ΔK) of 24.8 MPa·m^{1/2} (22.6 ksi·in.^{1/2}) at a frequency of 10 cycles per second. Much of the surface shows features resembling dimples, but the vertical "cliffs" are probably delaminations along grain boundaries. See 4028, a higher-magnification view of area in rectangle.

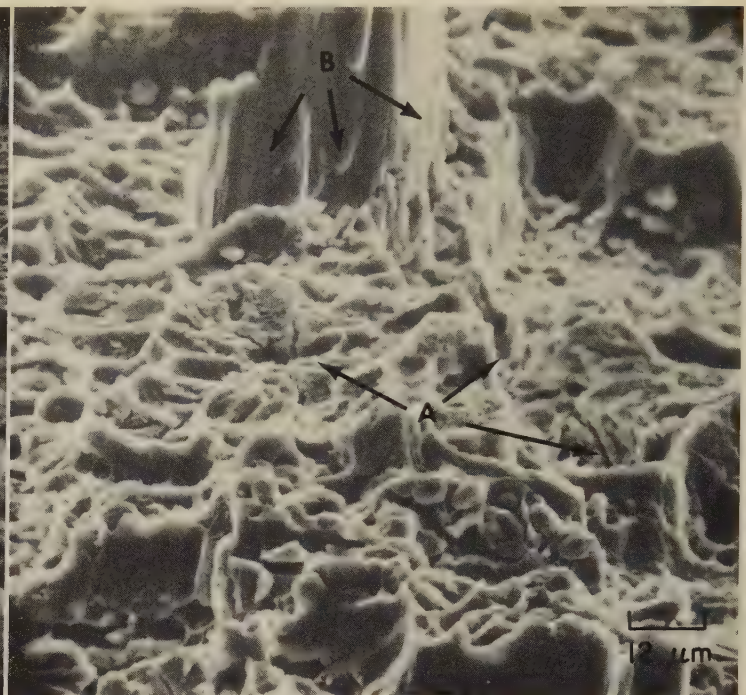
SEM fractograph

4028 Area outlined by the rectangle in fractograph 4027 (left), as seen at higher magnification. This view provides a much clearer delineation of the fine details of the fracture surface and shows a combination of dimpled rupture and grain-boundary separation. Intergranular secondary fissures such as those marked by the arrows at A led to the formation of the vertical "cliffs" shown here (arrows at B) and in fractograph 4027. Cracked and broken inclusions are visible at many locations.

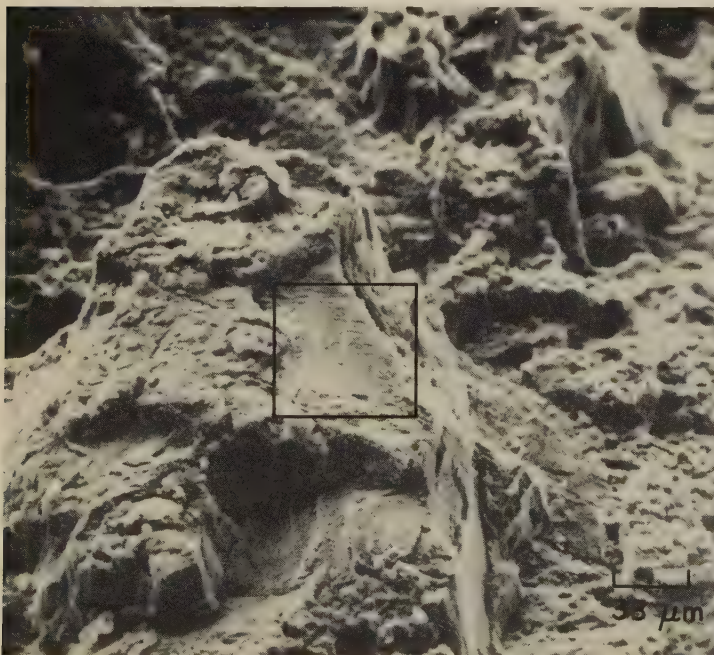
260×

4029 Fracture surface of a fatigue-test specimen of aluminum alloy 2024-T3 that was tested in an environment of a 3.5% solution of NaCl in water. The stress-intensity range (ΔK) was 19.8 MPa·m^{1/2} (18 ksi·in.^{1/2}) at 10 cycles per second. The central region of this view contains patches of well-defined fatigue striations. In adjacent regions, there appear to be faintly defined striae that have been obscured by corrosion. In other regions, it is uncertain whether fatigue or cleavage was active. See 4030 (area in rectangle).

4030 A view at higher magnification of the area outlined by the rectangle in fractograph 4029, showing the fatigue striations in finer detail. Note that superimposed on the fine striations at somewhat irregular intervals is a system of fissures, or perhaps more pronounced striations; the presence of these features may reflect either a repetitive variation in strain amplitude or stress, or periodic interruptions in the applied stress cycle (which allowed locally increased corrosion), or both.

4031 Fracture surface in a specimen of aluminum alloy 2024-T3 that was fatigue tested in a 3.5% NaCl aqueous solution under the same conditions as for the specimen shown in fractograph 4029 except for a higher stress-intensity range of 24.2 MPa·m^{1/2} (22 ksi·in.^{1/2}). One small region (at lower right) may contain fatigue striations; otherwise, the surface appears to be the result of a brittle type of fracture.

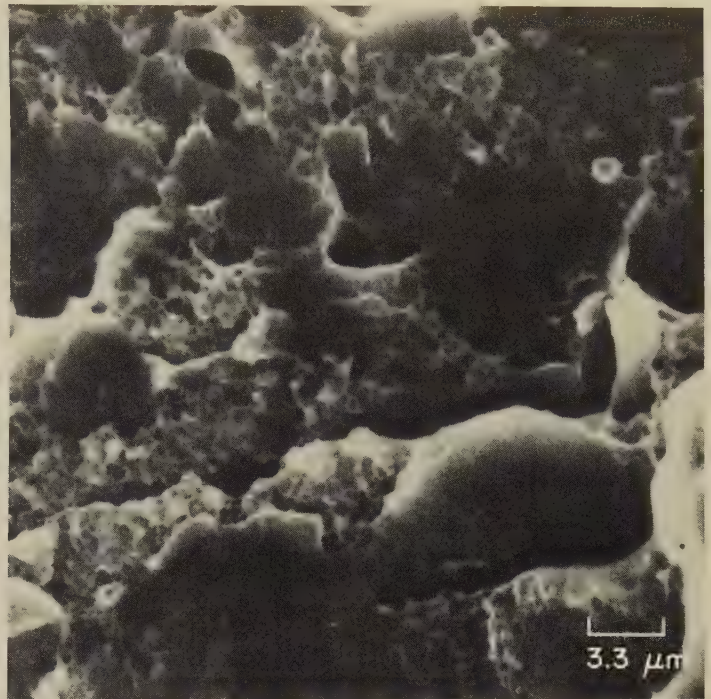
3000×

4032 Tension-overload fracture produced at room temperature in a specimen 1/8 in. wide by 1/2 in. long, cut from 0.03-in.-thick sheet of aluminum alloy 7075-T6 that had been solution heat treated at 460 C (860 F) and aged for 24 hr at 121 C (250 F). The material contained about 0.10 vol % of second-phase particles and was quite ductile, as evidenced by the small, equiaxed dimples. Compare with fractographs 4033 and 4034.

4033 Tension-overload fracture produced at room temperature in aluminum alloy 7075-T6 with the same heat treatment and specimen dimensions as described in 4032, but containing 0.54 vol % of second-phase particles. The plastic strain was 8%, which is less than the 13% for the specimen in 4032, but relatively large regions of ductile fracture are visible. Note the larger number of brittle particles here (arrows) than in 4032. See also 4034.

4034 A primarily brittle fracture produced in tension at room temperature in aluminum alloy 7075-T6 with the same heat treatment and specimen dimensions as in 4032 and 4033, but containing a large amount (1.19 vol %) of second-phase particles. Many of the second-phase particles are visible (arrows A). Equiaxed dimples are evident at locations where particles are absent (arrows B). Compare with the fracture surfaces in 4032 and 4033.

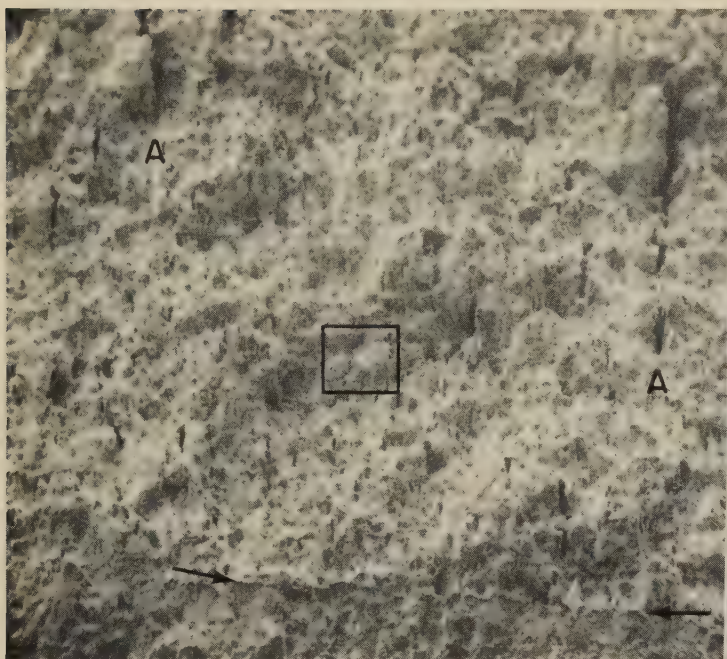
48×

4035 Fracture surface of a fracture-toughness test specimen of aluminum alloy 7075-T6, showing the zone of transition from the fatigue-precrack region (below arrows) to the tension-overload plane-strain fracture region (above arrows). Specimen was aged 24 hr at 121 C (250 F); tensile strength was 593 MPa (86 ksi), and uniform elongation was 13%. Note the appreciable number of vertical delaminations (as at A's), which probably are grain-boundary separations, caused by the transverse tensile stress in the plane-strain region. Area in rectangle is shown enlarged in 4036.

4036 Area outlined by the rectangle in fractograph 4035, as seen at ten times the magnification there. It is apparent that the matrix contained many second-phase particles that have undergone brittle fracture (arrows). The surface is quite complex, with some regions that appear to show clusters of minute dimples (A) and other regions that strongly resemble intergranular fracture (B's). At C is one of the numerous vertical fissures visible in 4035, presumably elongated during tension overload. See 4037 for a higher-magnification view of area in rectangle here.

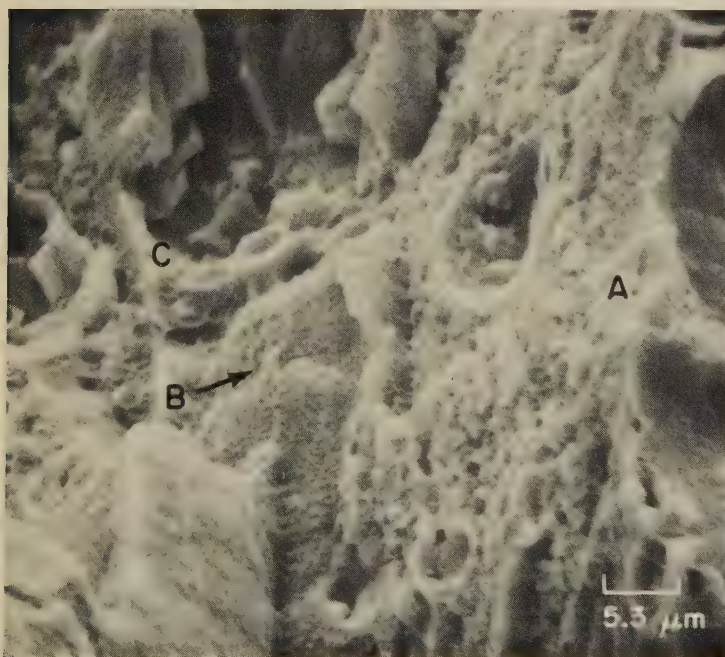
1900×

4037 Higher-magnification view of the area in the rectangle in fractograph 4036. At A is a region of extremely fine dimples, which are slightly out of focus. At B, there appear to be grain-boundary facets bearing small, very shallow dimples. At C are fragments of a number of second-phase inclusions, many of which have separated from their original pockets in the matrix.

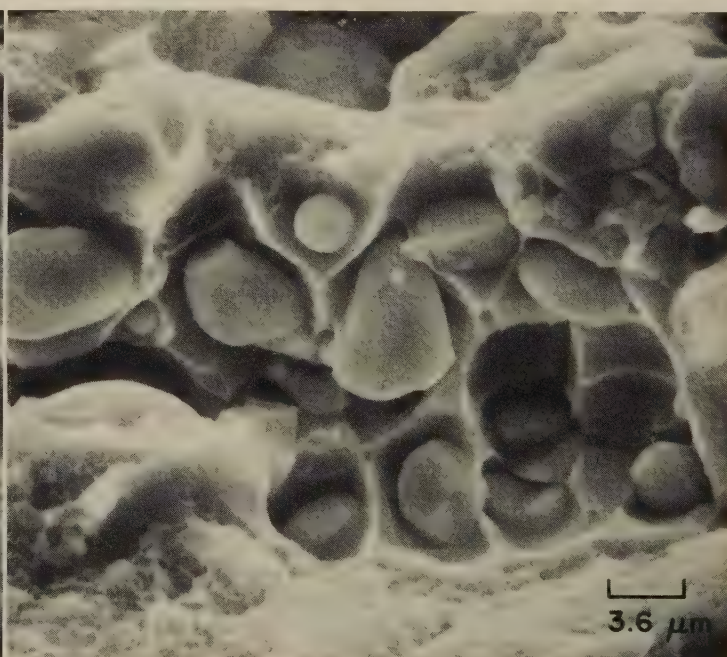
2800×

4038 Tension-overload fracture in the short-transverse plane of a specimen of aluminum alloy 7075-T6. At top and bottom are regions of quite small dimples. In the central portion of this view are large pockets in which the cleaved facets of intermetallic inclusions are visible. These inclusions, which are rich in iron and silicon, are only slightly bonded to the walls of the pockets.

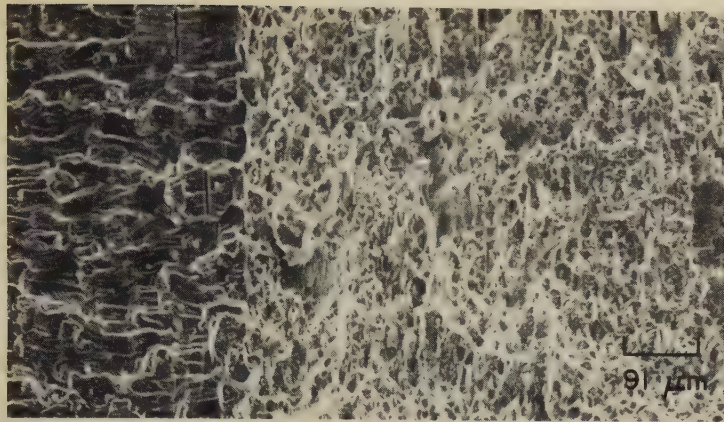
110×

4039 Specimen of aluminum alloy 7075-T6 broken in a slow-bend fracture-toughness test in air. Dark area, at left, is the fatigue-precrack surface, which shows no fatigue striae. At right is the tension-overload fracture surface; here, the surface appears dimpled, although this is uncertain at only 110×. See 4040.

4040 A portion of the tension-overload fracture surface in 4039, as seen at ten times the magnification there, which reveals fine details. A number of medium-size dimples contain inclusions, some of which are broken. In contrast are the minute dimples visible at left and right in the upper portion of this view.

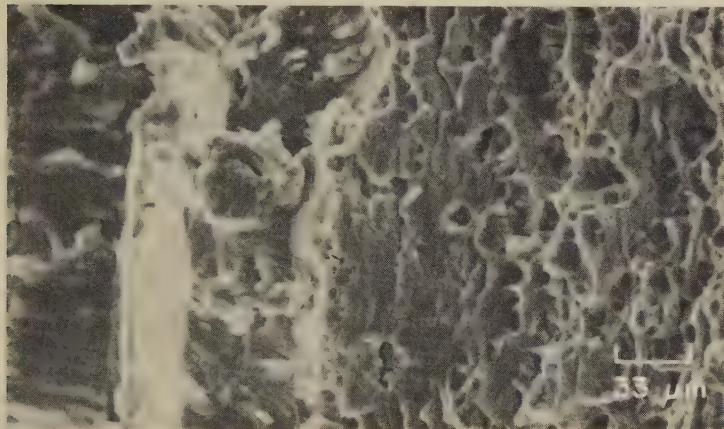
300×

4041 View of the transition between a slow-bend fracture induced in mercury vapor (left of center) and one occurring in air (right of center) in a specimen of aluminum alloy 7075-T6. The fracture induced in mercury vapor appears to have occurred by cleavage; the fracture in air exhibits dimples, which increase in frequency toward the right side of this fractograph.

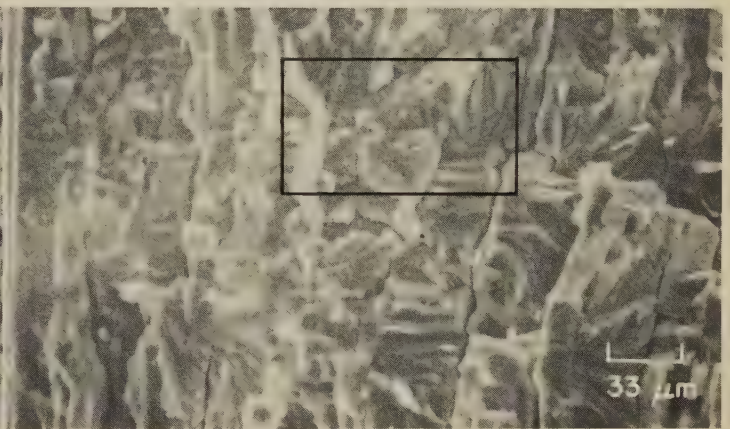
300×

4042 Fracture surface of an aluminum alloy 7075-T6 specimen broken in a slow-bend fracture-toughness test in mercury vapor. Obviously, a completely brittle fracture. Many facets show faint characteristics of quasicleavage. Note the large number of secondary cracks, possibly at grain boundaries, all of which are more or less parallel. Area in rectangle is shown enlarged in 4043.

4043 Higher-magnification view of the surface contours outlined by the rectangle in 4042. This reveals the cleavage river patterns quite clearly; note the changes in fracture direction at right. This view also reveals the depth and continuity of the secondary cracks. See also fractograph 4044, at right.

4044 Another view, at still higher magnification, of the fracture surface in 4042 and 4043. At top is what appears to be a pocket holding a cracked inclusion. The remainder of the surface shows cleavage facets plus projections that are somewhat similar to the tongues seen in cold fractures of iron.

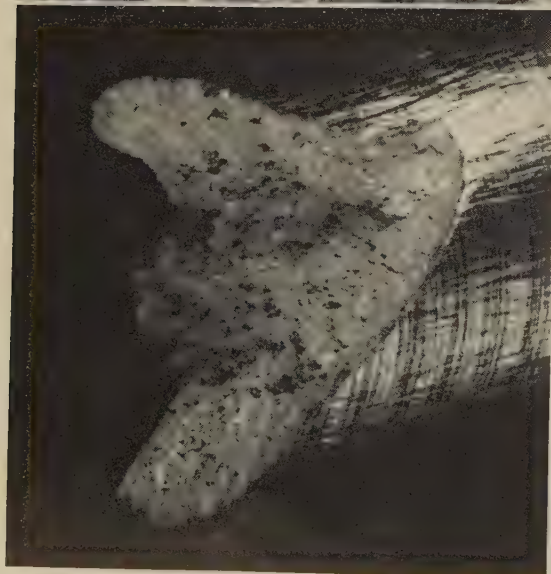
Light fractograph
4045 Surface of a tension-overload fracture in an unnotched specimen of aluminum alloy 7075-T6 having tensile strength of 520 MPa (75 ksi), with 22% reduction in area. Surface is coarsely fibrous; shear lip has formed two opposing lobes. See also 4046 and 4047, at right.

Light fractograph
4048 Tension-overload fracture in notched specimen of aluminum alloy 7075-T6. Notched tensile strength, 750 MPa (109 ksi); unnotched tensile strength, same as 4045. Surface is flat and coarsely fibrous. Considerable secondary cracking is evident, even at this low magnification. See 4049 and 4050.

SEM fractograph
4046 A scanning electron microscope view of the central area of the fracture surface in 4045. Although this is a ductile rupture, it contains very deep secondary cracks. The major pores were sites of alloy second-phase particles that are no longer in place. See 4047 for an enlarged view of area in rectangle.

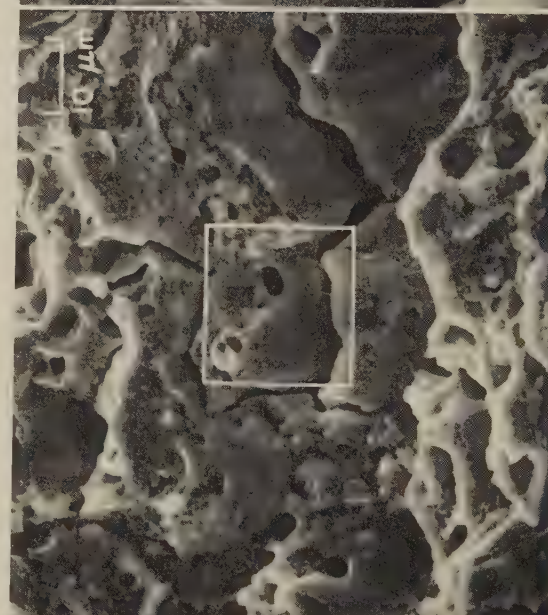
SEM fractograph
4049 A scanning electron microscope view of the interior of the fracture surface in 4048. This shows that in general the secondary cracking is intergranular, although the primary rupture is not. Numerous pores contain alloy second-phase particles. See 4050.

SEM fractograph
4050 Higher-magnification view of the area outlined by the rectangle in 4049. This fourfold enlargement makes visible the fine dimples surrounding the particle sites. Note that the surfaces of the secondary grain-boundary cracks are remarkably smooth.

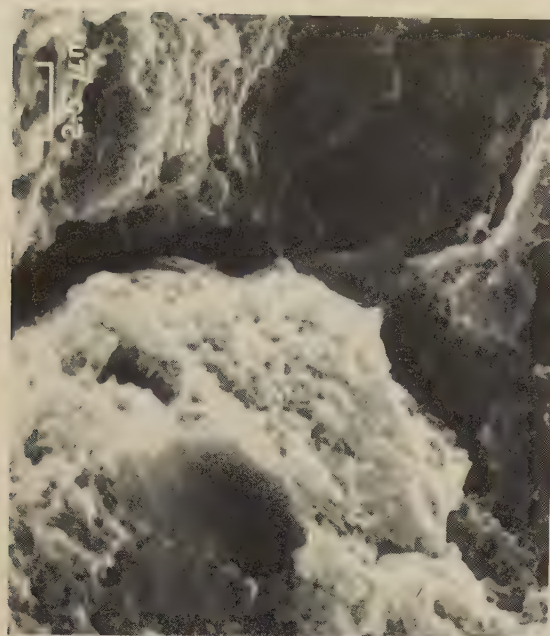
SEM fractograph
4047 Enlarged view of the fracture-surface area outlined by the rectangle in 4046. The higher magnification here makes it possible to observe the fine size of the dimples, which in general is less than half a micron. This is a remarkable uniformity of size in a fracture surface as rough as this one.

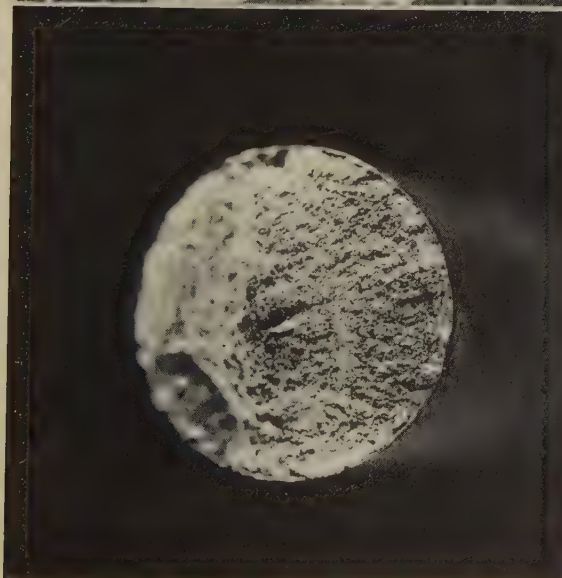
6×

4051 Cone-shaped fracture surface produced by low-cycle fatigue in aluminum alloy 7075-T6 (same mechanical properties as in 4045). Loading was tension-tension with $R = 0.1$ and a maximum loading of 310 MPa (45 ksi). Fracture occurred at 26,000 cycles. See also fractographs 4052 and 4053.

4052 Scanning electron microscope view of a very complex surface found near the outer edge of the fracture in 4051, believed to have formed principally by severe deformation by slip. There appears to be a complete absence of secondary cracks. See 4053.

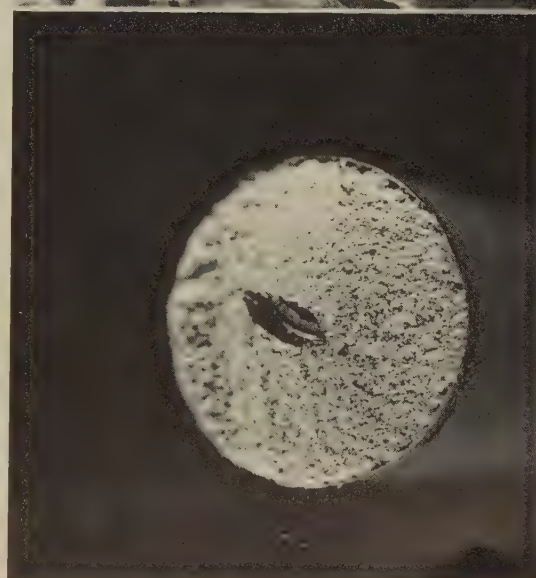
6×

4054 High-cycle fatigue fracture in aluminum alloy 7075-T6 (same mechanical properties as in 4045) loaded in tension-tension with $R = 0.1$ and a maximum loading of about 159 MPa (23 ksi). Fracture was at 548,000 cycles. Gauge near center is post-test mechanical damage. See also 4055, at right.

4055 A view of the fracture surface in 4054 that is very similar to the view of the low-cycle fracture surface in 4053. It is believed that the steplike formations resulted from a slip mechanism. Secondary cracks are not visible. See fractograph 4056.

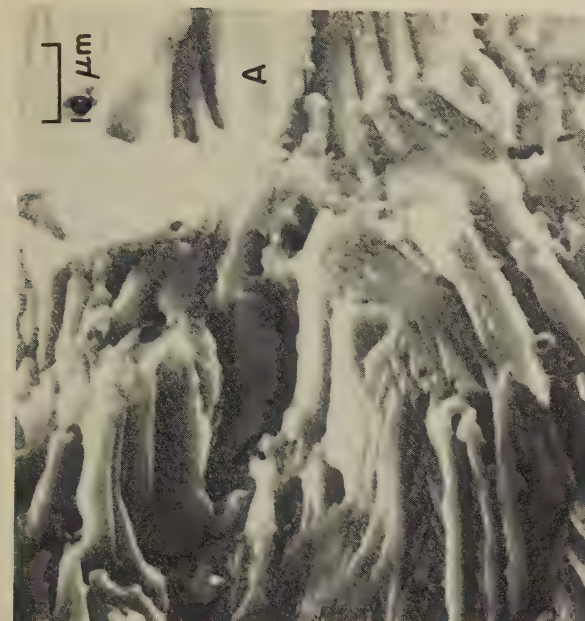
1000×

4053 A view at higher magnification of the area in the rectangle in 4052. Fatigue striations with a spacing of about $0.5 \mu\text{m}$ were discerned at region "A" when magnified at 4000 \times , oriented at a slight angle counterclockwise to the vertical edge of this print.
